Causes of the Collapse

Overview: A rusted weld lost its strength

On June 23, 2012, at 2:18 p.m., a portion of the parking deck level of the Algo Mall collapsed into the retail space below. Following the collapse, the Ontario Provincial Police (OPP) began a criminal investigation and retained NORR Limited (NORR) to carry out a forensic investigation into the cause.¹ NORR is a multidisciplinary firm composed of architects, engineers, and planners.

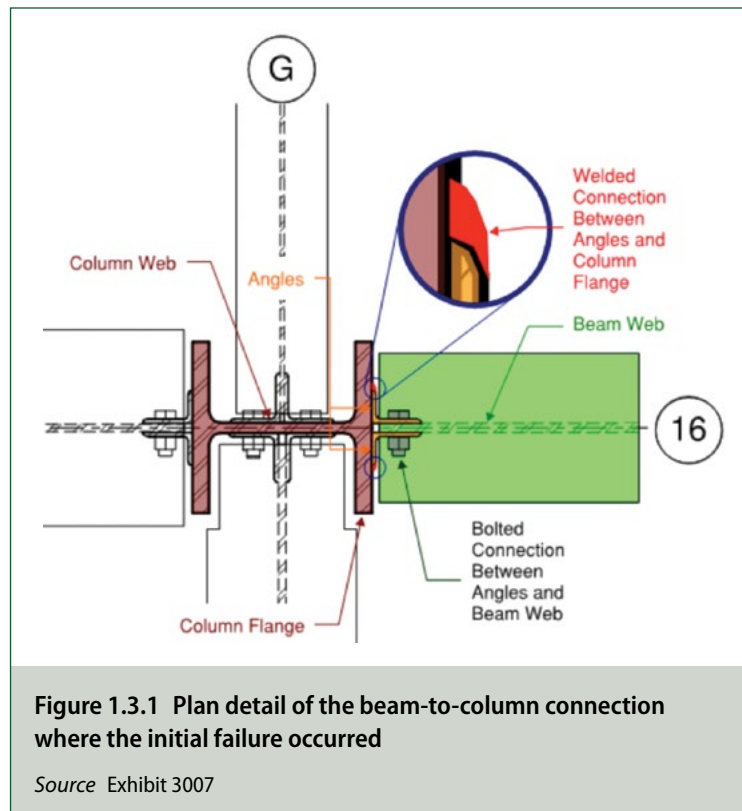
On June 23, 2012 a portion of the parking deck level of the Algo Centre Mall collapsed into the retail space below. The collapse initiated due to a failure of a beam to column connection supporting the parking deck HCS [hollow core slab]. The steel framing for the extent of the area affected by the collapse at the parking deck level is provided in Figure 3-1. The connection which failed consisted of two steel angles bolted to the web of the W24x110 beam running along gridline 16 and welded to the flange of the column at gridline intersection G-16. The failure occurred in the welded connection between the steel angles and the flange of the column.⁹

NORR also provided two diagrams of the failed beam-to-column connection and the location where the failure occurred (see figures 1.3.1 and 1.3.2).

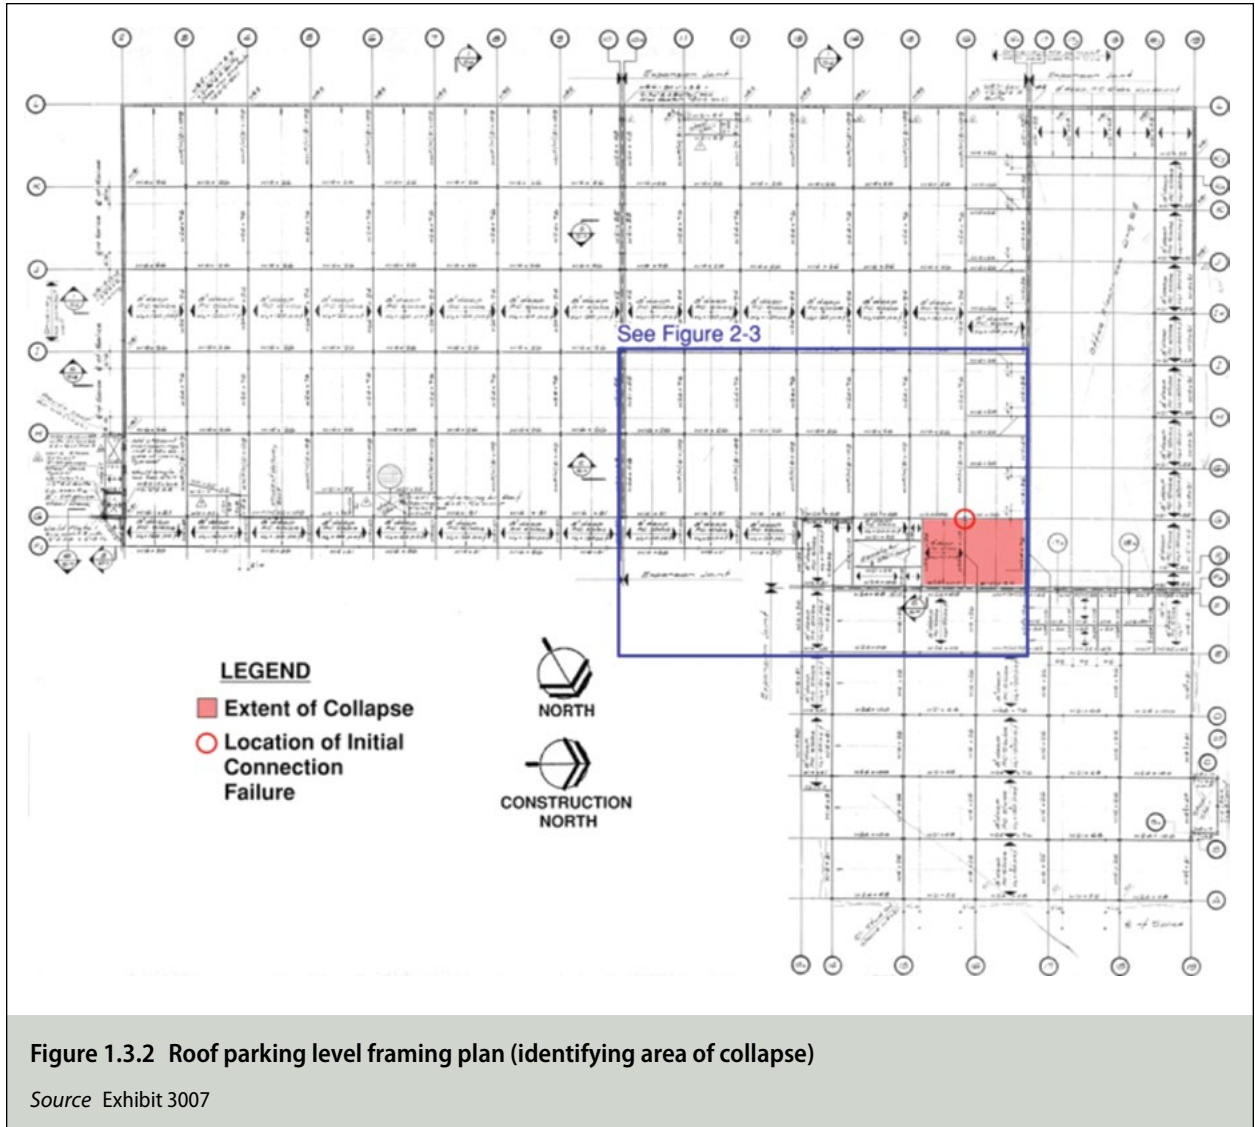
Figure 1.3.2 Roof parking level framing plan (identifying area of collapse)

As early as August 1981, leaks were discovered along gridline 16, in front of the escalator, over the beam that ultimately collapsed. This leak was the first documented evidence at the Inquiry of a problem at this location, and continuing leaks there caused the corrosion of the weld that led to the collapse.³⁴

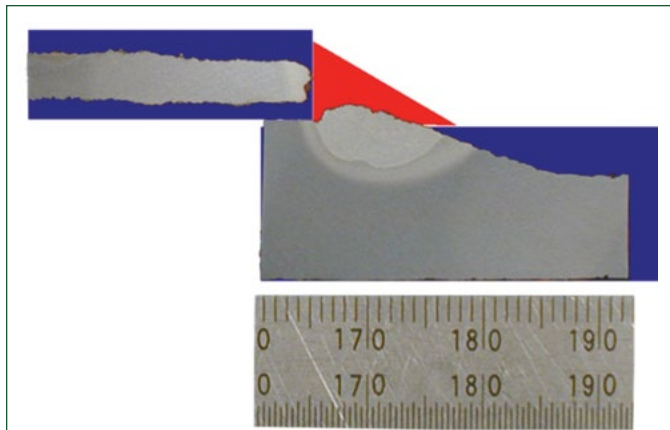
The BMT report,²³ which is an appendix to the final NORR report, outlined both the process followed to compare the welds and the indicators used to determine the likely as-built condition in 1979–80 of the failed weld. The BMT report contains complex and detailed information on the process and the comparisons undertaken in this attempt. It explained that, during the welding process, the heat required to weld the metals together creates a heat-affected zone that can be seen through metallographic examination.²⁴ The contours of the heat-affected zones (also described as a “halo” in the BMT report) were used to determine the geometry (shape and size) of the original weld (see figure 1.3.3).

Figure 1.3.3 Metallographic examination showing geometry of the weld at the time of failure, and red triangular background to illustrate the nominal weld size considered to have been used at the time of original construction

BMT concluded that the weld of the failed connection in its original state would likely have been consistent with the Code requirements at the time of construction.²⁵ It found that, compared with today's standards, the original weld was generous and would have been using only 60 percent of the capacity for which it was designed. In other words, it was stronger than what had been specified, so there was a higher margin of safety. If the weld had not been corroded, there would have been no issue of its capacity.²⁶

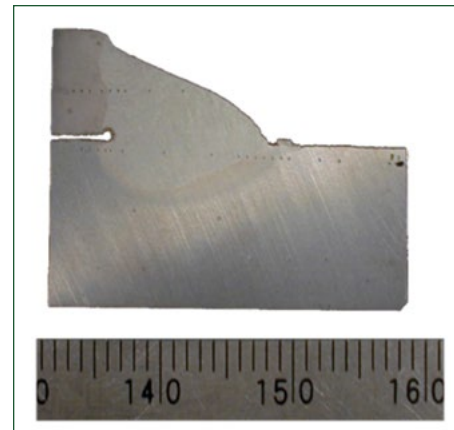
NORR was able to locate a connection in the Mall that showed almost no signs of corrosion (the “reference weld”).²¹ Although this connection was significantly larger than the one that failed, the NORR team determined that it could use it for comparison purposes.²² Mr. Dinovitzer of BMT was responsible for determining the likely as-built condition of the way the steel angle had been welded to the column of the failed connection.

By comparing what would have been the geometry of the original weld to the other connections in the Mall, NORR determined that it was more than likely that the failed weld had been constructed in a manner similar to the reference weld (see figure 1.3.4).

Figure 1.3.4 Reference weld used to determine nominal weld size at the time of original construction

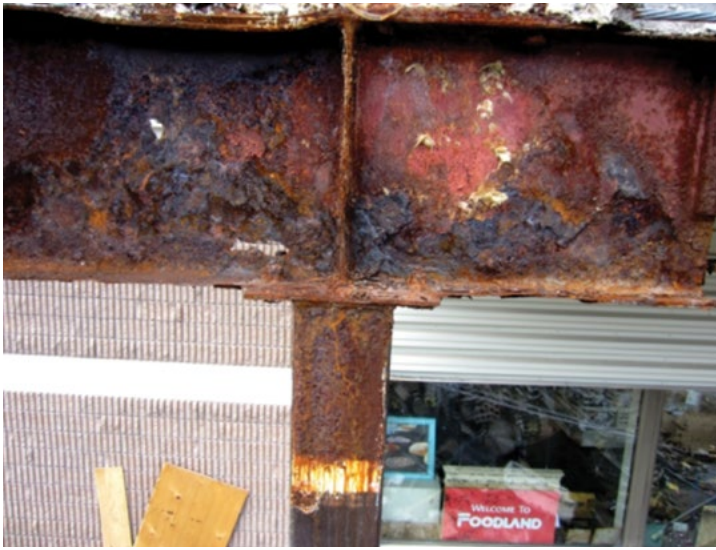
Figure 1.3.5 Severely corroded connection at the pedestrian walkway located at gridline E-13x

In addition to the interior of the Mall, the NORR team also inspected the pedestrian walkways located at the exterior perimeter. After removing the exterior cladding, the inspectors found some of the most severe corrosion there. In its report, NORR stated: “Beam flanges and stiffeners were reduced to almost nothing in some locations and more penetrations were uncovered through members.”⁵⁵ The team’s concerns were demonstrably and starkly illustrated by a significant number of photographs presented during the Inquiry showing the condition of the Mall. Any neutral observer of such egregious deterioration must be troubled by its logical implications. It speaks of glaring inattention, neglect, and lack of proper maintenance by the owners of the Mall during its lifetime (see figure 1.3.5).

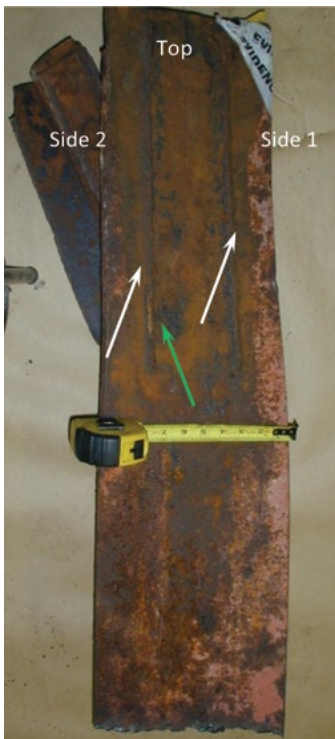
Although BMT assisted Giatec and NORR in estimating the rate of corrosion at the Mall, its main focus was the connection detail that was suspected of precipitating the collapse.⁶² BMT was provided with the section of the column flange of the failed connection as well as with its beam and bolted angles. The separation of the connection occurred at the welds joining the two angles to the column flange (see figure 1.3.6).

Figure 1.3.6a Column flange of failed connection

- The failure of the surface on the column flange was entirely within the weld.
- Pits along the failure surface suggested that this surface had been exposed to a corrosive environment for a significant period of time; in addition, corrosion deposits were seen in the pits.
- The failure surface revealed no observable grain deformation, indicating that there had been no stretching or pulling of the metal and therefore no rotation or prying of the metal before the failure (other than the deformation referenced above).
- The failure surface of the welded connection on the beam did not display weld metal; that fact, together with the first point above, meant that the fracture path followed the weld fusion line – the border between the weld metal and the base material at the angle.⁶⁷

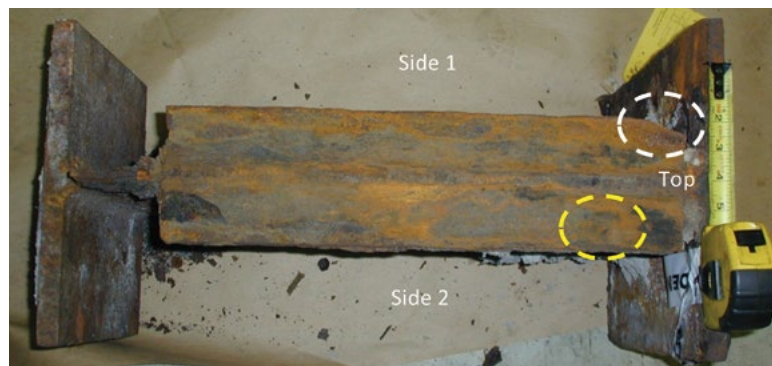
Figure 1.3.6b Top view of the failed beam connection showing that the angle and bolted connection were severely corroded

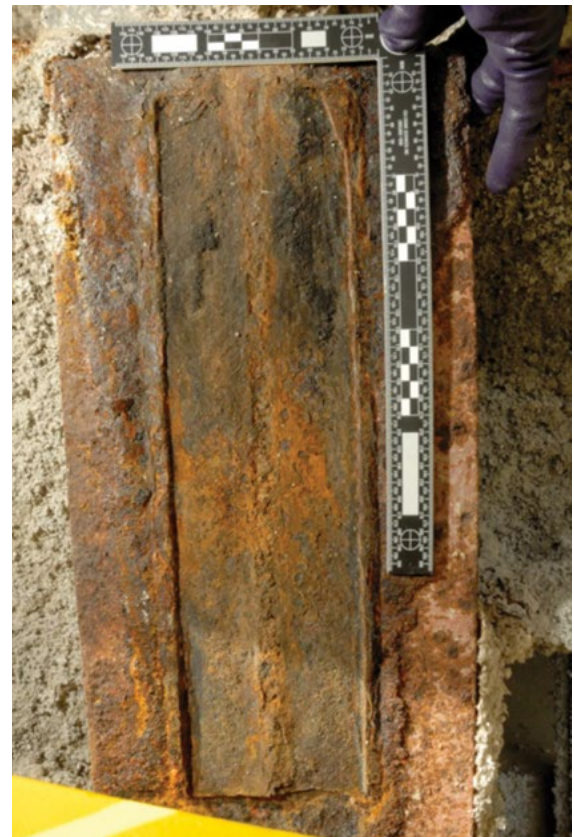
From NORR's perspective, the cause and mechanism of the collapse were evident. The connection of the beam to column G16, on gridline 16 between gridline Fx and G, failed in shear because of the loss of section of the weld. NORR specifically noted: "In fact the remaining weld after years of corrosion is so small that justification for the ability of the beam to support its own and the concrete above was subject of further testing and analysis." The condition of the column flange and the steel angles at the beam end as they existed at the time of the collapse is depicted in figure 1.3.7.

NORR determined that the force applied to the connection at the time of failure was approximately 50 percent of the design factor load. The team concluded that, on the day of the collapse, the welded connection was depleted to the extent that the car seen driving in the video footage over the area in the seconds before the collapse was the proverbial "straw that broke the camel's back." The connection could no longer carry any more weight, and the remaining weld sheared, leading to the immediate and sudden collapse. NORR determined that the portion of the weld which remained in place immediately before the collapse had only 13 percent of its original capacity.⁷⁰

Figure 1.3.7 Face of the column flange at gridline G-16 and the beam and angle that were connected to the column flange before failure
