1986–99: Leaks Persist – The Problem Will Be Sold

1986–9: The first years of Rod Caughill’s employment by Algocen	137
Rod Caughill learns of the leaks soon after being hired	137
Mr. Caughill is asked to look for solutions.	137
1987: Algocen develops a maintenance routine that includes daily checks for loose caulking and water-damaged tiles.	138
1988–9: The Library moves to the Mall, despite warnings about leaks.	139
1989: Ken Snow is hired by Algocen as the maintenance supervisor for the Algo Centre and observes visible leaks	141
1990: The City is hit by mine shutdowns, the leaks persist, and the owner continues to deal with the roof in the same way	142
The City suffers a significant blow	142
The Mall continues to lose money for Algocen	144
Algocen documents its roof maintenance procedures, which never changed	144
1990, A particularly bad year for leaks: Algocen is warned, and agrees, that the roof will “be a problem forever” – and continues to repair it in its usual way	145

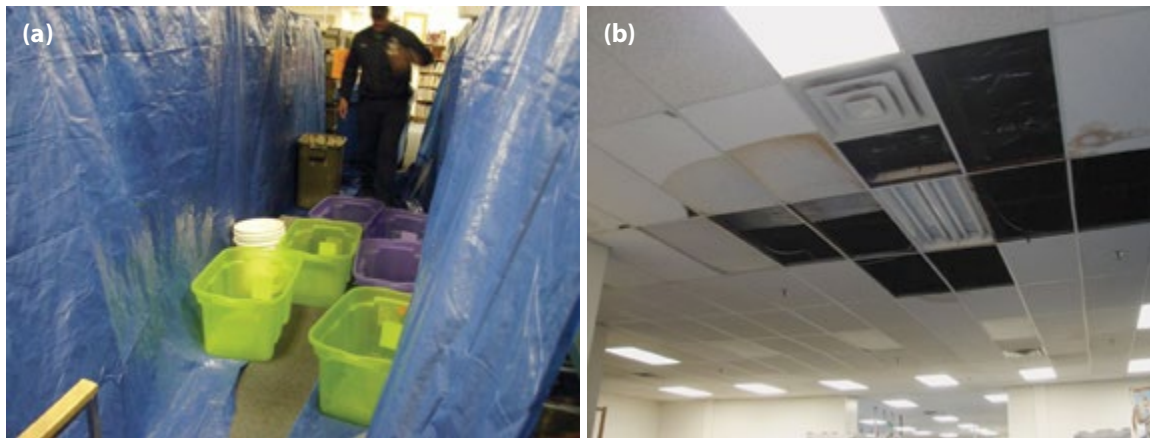
Ms. Fazekas provided vivid testimony about the difficult situation created by the persistent leaks at the Library in this time frame. She described how buckets and tarps needed to be brought out each time it rained, but the leaks were unpredictable. There were no windows in the Library, and at times the staff was unaware it had started to rain until the water started to come in. It rarely leaked in the section of the Library located under the Hotel. Leaks were frequent in the section of the Library directly under a high-traffic area for the parking lot above.† The staff had to cover this whole section of the Library virtually every time it rained (see fig.1.5.3).¹³³

Figure 1.5.3 (a) Buckets and tarps are used to catch leaks and cover large sections of books in the Library; (b) numerous tiles missing in the Library ceiling due to leaks

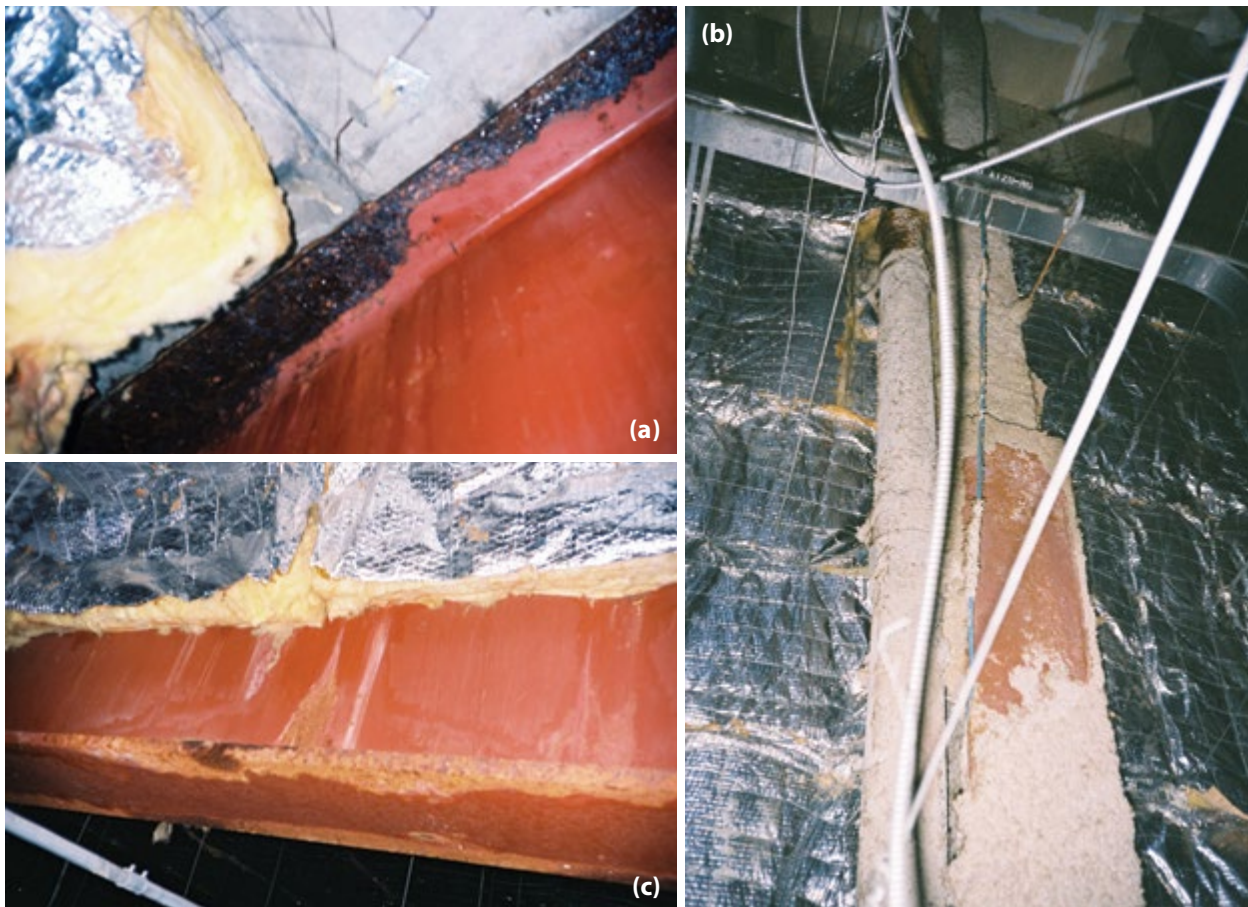
The structural steel members are sound with some surface corrosion. The chloride ion content is generally higher in the concrete topping and contamination of the precast slab is at its initial stage. Corrosion of the embedded reinforcement can be expected to continue at all areas of leakage.²⁸⁷

Photographs from the 1994 inspection show increased leaks and damage since the 1991 survey

Figure 1.5.4 (a) evidence of corrosion on the top flange of a beam; (b) missing fireproofing on a column; and (c) evidence of corrosion on the bottom flange of a beam.
