Report of the Elliot Lake Commission of Inquiry

Executive Summary

The Honourable Paul R. Bélanger
Commissioner

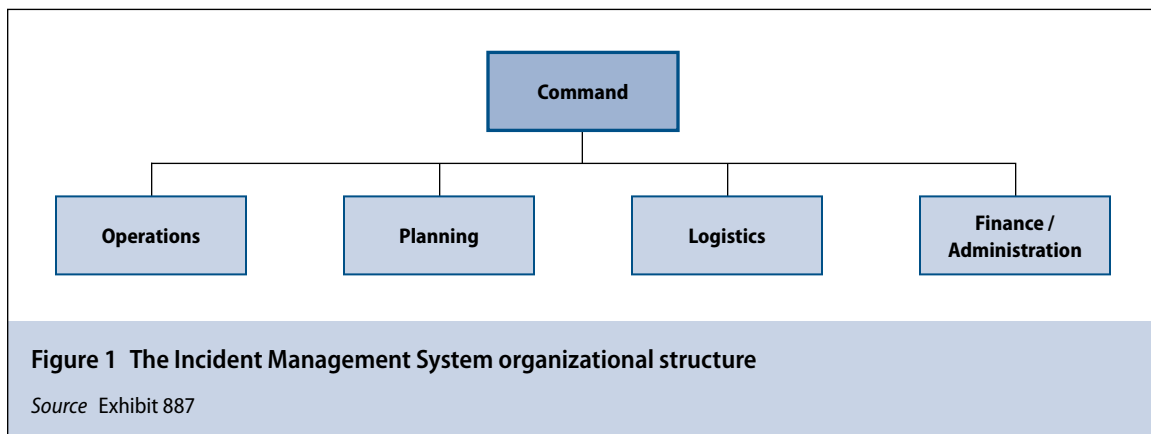
Ontario has developed and promoted the Incident Management System (IMS) for emergency management. It is standardized and "scalable" to any size of response and is structured around five major management functions that are expected to form part of every incident response: command, operations, planning, logistics, and finance and administration (fig. 1).

Under the IMS doctrine, there are two models of incident command: single and unified. Single command is under the head of one rescue team, while unified command is in essence under a committee drawn from some or all of the response organizations deployed to the scene. Once the command structure is established, either single or unified, IMS calls for an incident action plan, which, depending on the complexity of the situation, can be oral or written. Its purpose is to provide clear, strategic, and tactical direction to the response. Initial and ongoing briefings should occur – to explain the plan, revisit it, and consider “Plan Bs” if necessary.
