Mall Deteriorates amidst Inaction

In 2011 pieces of concrete fell from the hollow core slabs

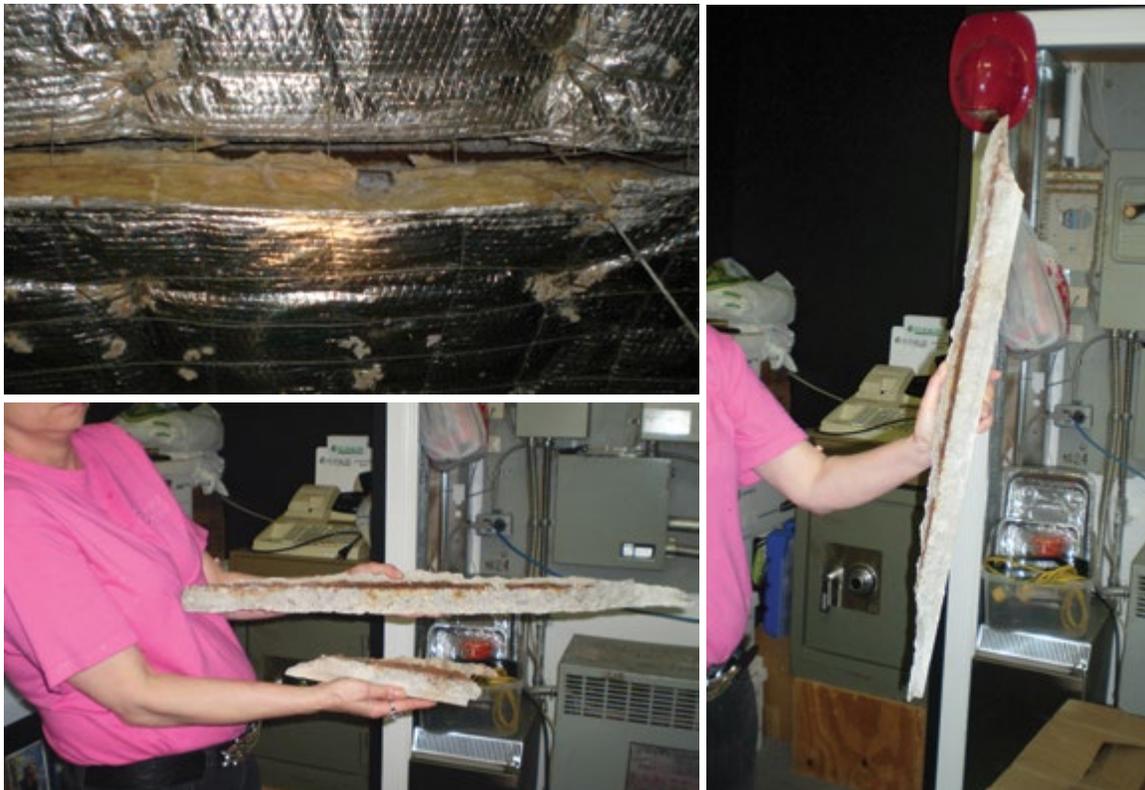
On the day in question, Mrs. Quinte arrived at Hungry Jack's at approximately 7:00 a.m. and noticed debris on the floor that she described as pieces of crushed concrete. When she looked up at the ceiling above the debris, she noticed something protruding from the ceiling tile. She described it as "a spearhead that had come through the tile." It was ultimately determined that two pieces of concrete had broken from the hollow core slabs above, one piece smaller than the other. Those pieces were protruding through the ceiling tiles.³

The photographs taken by Mr. Hammond and Mrs. Quinte depicted

- the wire mesh holding the insulation in place, through which the concrete had fallen;
- the larger of the two pieces of concrete that had fallen through the ceiling tiles; and
- the smaller of the two pieces of concrete that had fallen through the ceiling tiles (see figure 1.12.1).

Figure 1.12.1 Pieces of hollow core slabs fall through wire mesh into ceiling tiles at Hungry Jack's

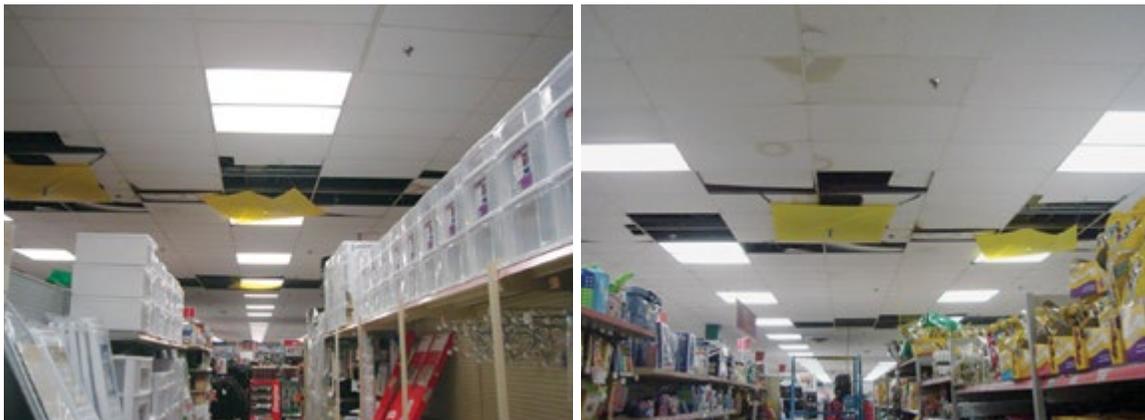
Mr. Hudson was in the Mall on December 4, 2007, for an investigation at Foodland. This was a particularly bad day for leaks at Zellers. Photos of the store that day (figure 1.12.2) show large numbers of missing ceiling tiles and prominent yellow bladders suspended from the ceiling to catch roof leaks.¹⁰⁷ Mr. Hudson could not recall seeing missing ceiling tiles at any of the times he went into Zellers, and he did not go into the store on this particular day.¹⁰⁸

Figure 1.12.2 Conditions in Zellers the day a Ministry of Labour inspector visited the Mall in December 2007
